**DEPARTMENT OF TRANSPORTATION****DIVISION OF ENGINEERING SERVICES**

Contract #: 04-0120F4Cty: SF/ALA Rte: 80 PM: 13.2/13.9File #: 69.28**WELDING INSPECTION REPORT****Resident Engineer:**Pursell, Gary**Address:** 333 Burma Road**City:** Oakland, CA 94607**Report No:** WIR-015609**Date Inspected:** 13-Jul-2010**Project Name:** SAS Superstructure**OSM Arrival Time:** 700**Prime Contractor:** American Bridge/Fluor Enterprises, a JV**OSM Departure Time:** 1900**Contractor:** Zhenhua Port Machinery Company, Ltd (ZPMC), Changxing Island **Location:** Shanghai, China**CWI Name:** Yang Bai Qiang**CWI Present:** Yes No**Inspected CWI report:** Yes No N/A**Rod Oven in Use:** Yes No N/A**Electrode to specification:** Yes No N/A**Weld Procedures Followed:** Yes No N/A**Qualified Welders:** Yes No N/A**Verified Joint Fit-up:** Yes No N/A**Approved Drawings:** Yes No N/A**Approved WPS:** Yes No N/A**Delayed / Cancelled:** Yes No N/A**Bridge No:** 34-0006**Component:** OBG**Summary of Items Observed:**

BAY 04, DECK PANEL REPAIR

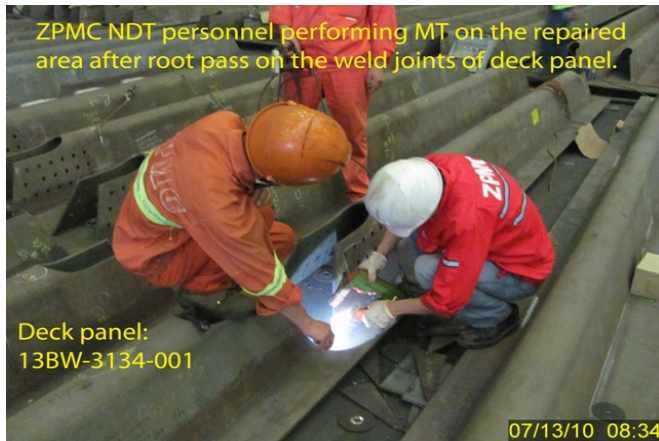
13BW-DP3134-001

This QA inspector observed that ZPMC NDT personnels were performing Magnetic Particle Testing (MT) on the repaired area after root pass on the weld joints of above mentioned deck panel. Attached photograph provides additional details.
